QA-685

227 Riverview Ave Road

Stevensville Vicinity, Queen Anne's County

Maryland Inventory of Historic Properties Form

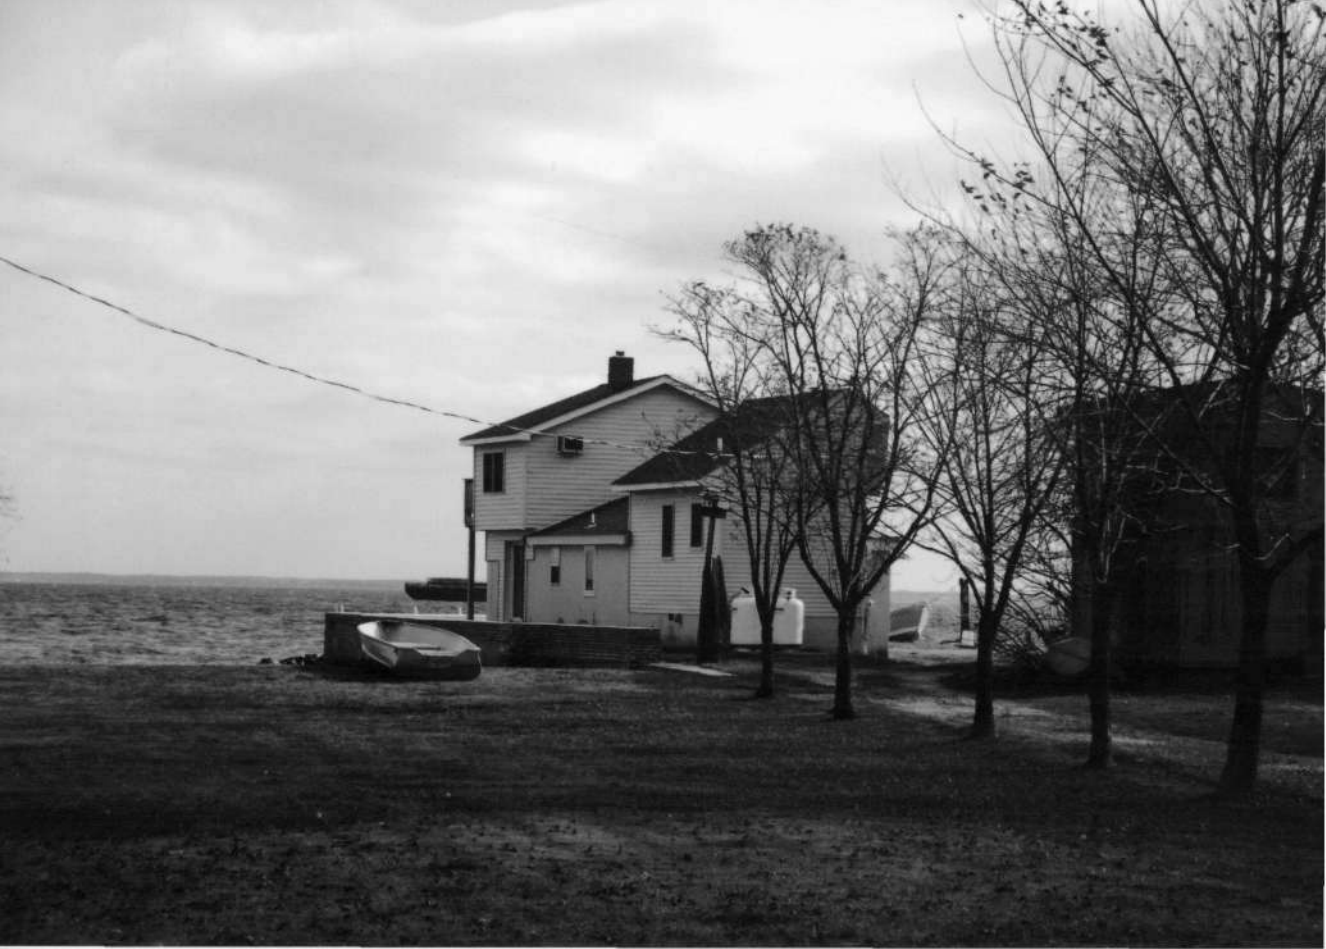
1 of 1

The western section of the dwelling is one-and-one-half stories high with a saltbox style roof, this roofline also running perpendicular to the coastline. The shorter roof is on the south elevation. This section rests on a concrete block foundation.

All sections of the dwelling are covered in an asphalt-shingled roof and exhibit asymmetrical fenestration. A two-story porch is located on the east elevation.

PERSPECTIVE VIEW OF NORTH & WEST ELEVATIONS
LOOKING SOUTHEAST.
